BEATRIX GOLD MINE

Carbon Breakage Investigation

By: Sello Damoyi

24 October 2008

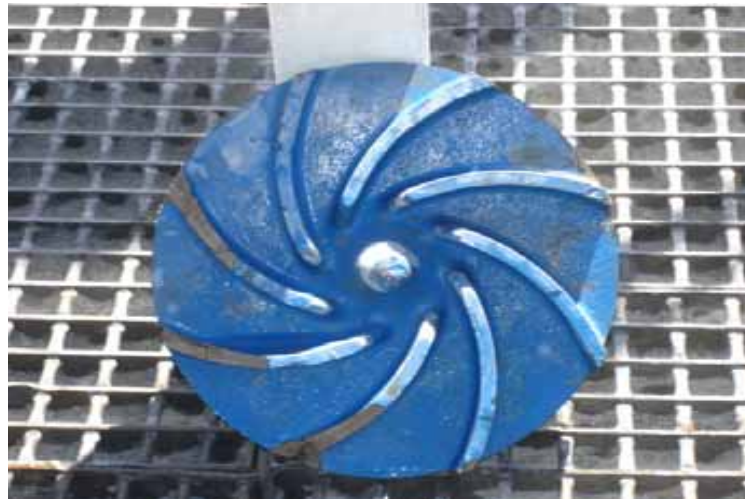
Interstage carbon transfer pumps are used with chipped impeller edges

Rubber – lined 150 mm diameter impeller	R	80 000
200 mm diameter piping @ R500 / m	R	100 000
Pressurized Transport tanks	R	200 000
Glass Fibers Seal for A - Kiln	R	8 000
Purchase B - Kiln	R	1.7 Million
Sub - Total	R	2 088 000
50% Contingency	R	1 044 000
Total CAPEX required	R	3 132 000

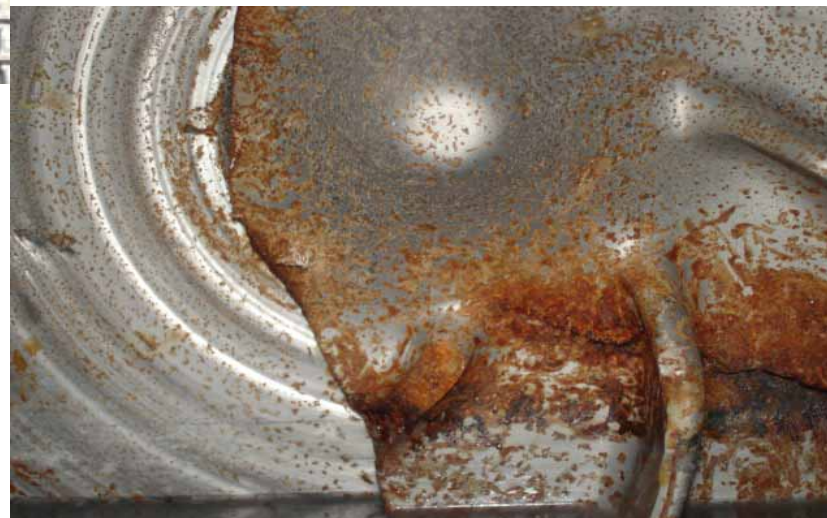
Broken and worn – out impeller on head tank agitators

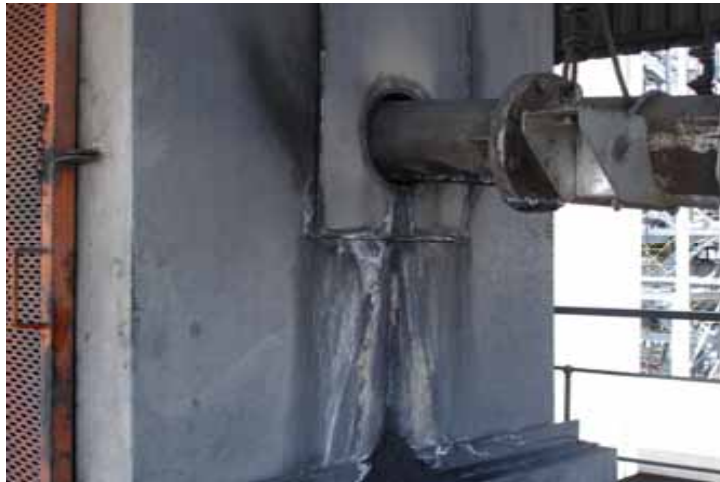
Regeneration kiln holed on feed – point without seal.

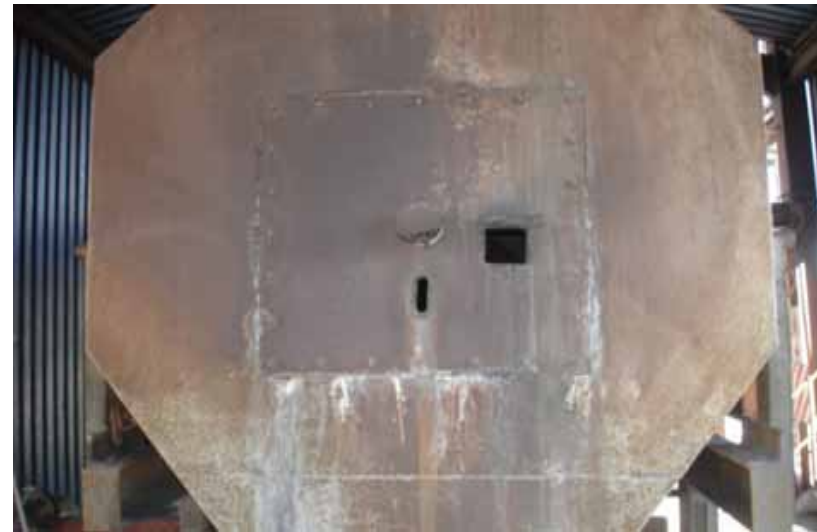
Damaged seal ring and holed discharge point

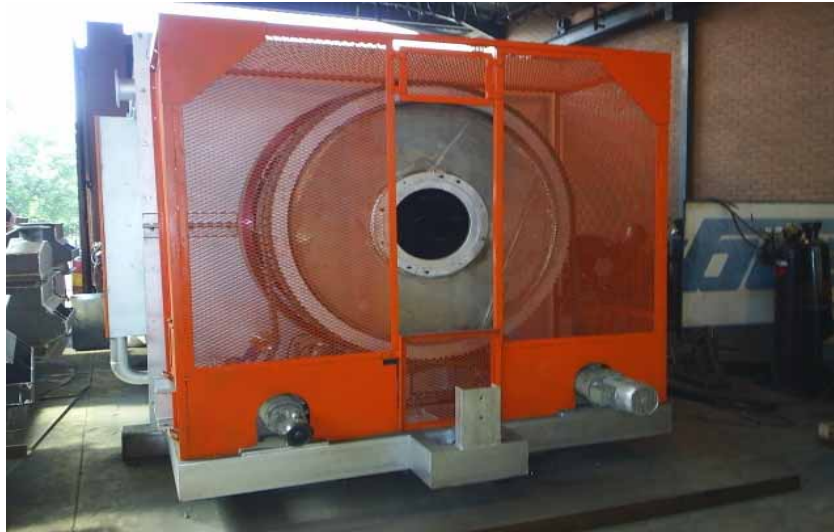
New kiln purchased and assembled

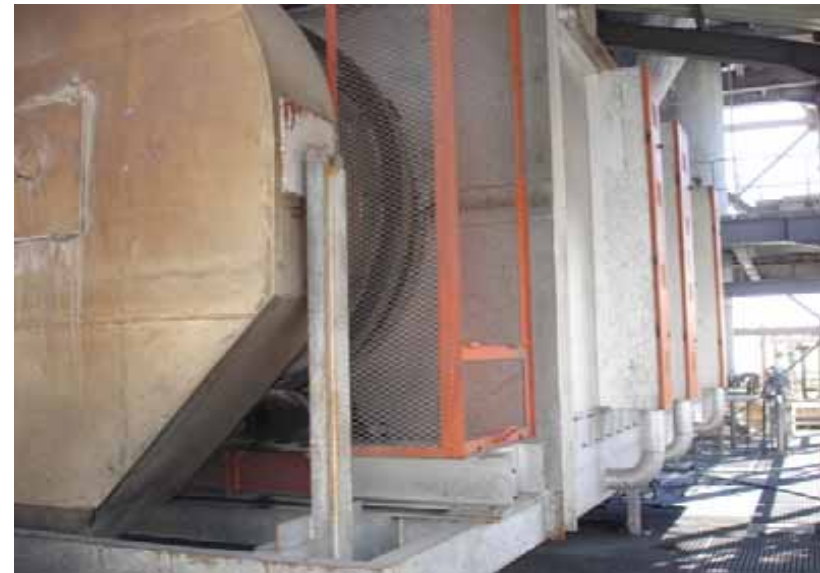
Kiln installed
