INCIDENTES

Incident type and consequence: Actual: Lost Time Injury – Potential: Fatality	Incident Date and Time: 17 Sep 08 / 08:30 Site: Cerrejón Coal - Country: Colombia
Contractor Incident – Dept.: Operation Services / Eng. & Construction	Incident Id: 17823

SHEC High Potential Incident: Contractor employee suffered burns when a lightning struck a pick-up truck buggy whip parked in construction area.

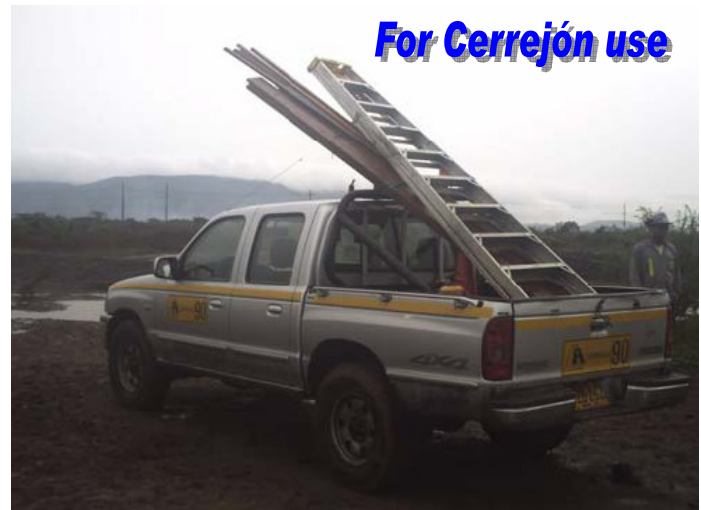
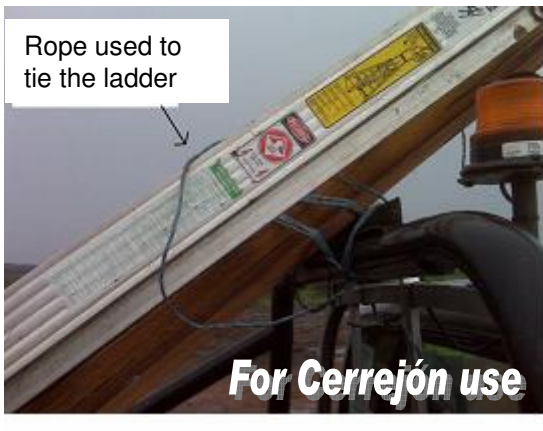
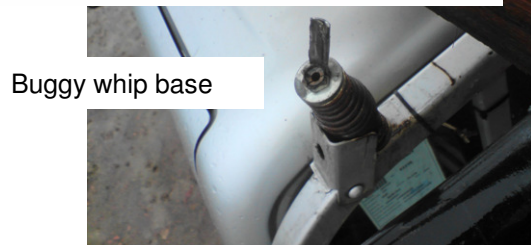
A laborer employed by Gayco, a construction contractor, suffered whip-like second and third degree burns in his arm and thorax. The incident occurred in the construction area of a change house at the New Mining Areas, which is an open area without permanent facilities and still without lightning protection. The construction work had been stopped due to the rain and the laborer was securing a portable ladder they had placed on the pick-up truck body, when a lightning struck the pick-up truck buggy whip.

Contractor risk register had not considered the risk of lightning.

Under storm condition avoid working or playing sports at open areas. Stay inside a vehicle or inside a covered area, and away from trees or high structures without lightning protection.
