IMPALA PLATINUM LIMITED

Safety Flash No: 01/04

Impala Mineral Processes has experienced four safety incidents in the last four months involving diluted liquid xanthate and dithiophosphate. This safety flash describes the incidents, the learning points, and the remedial action taken.

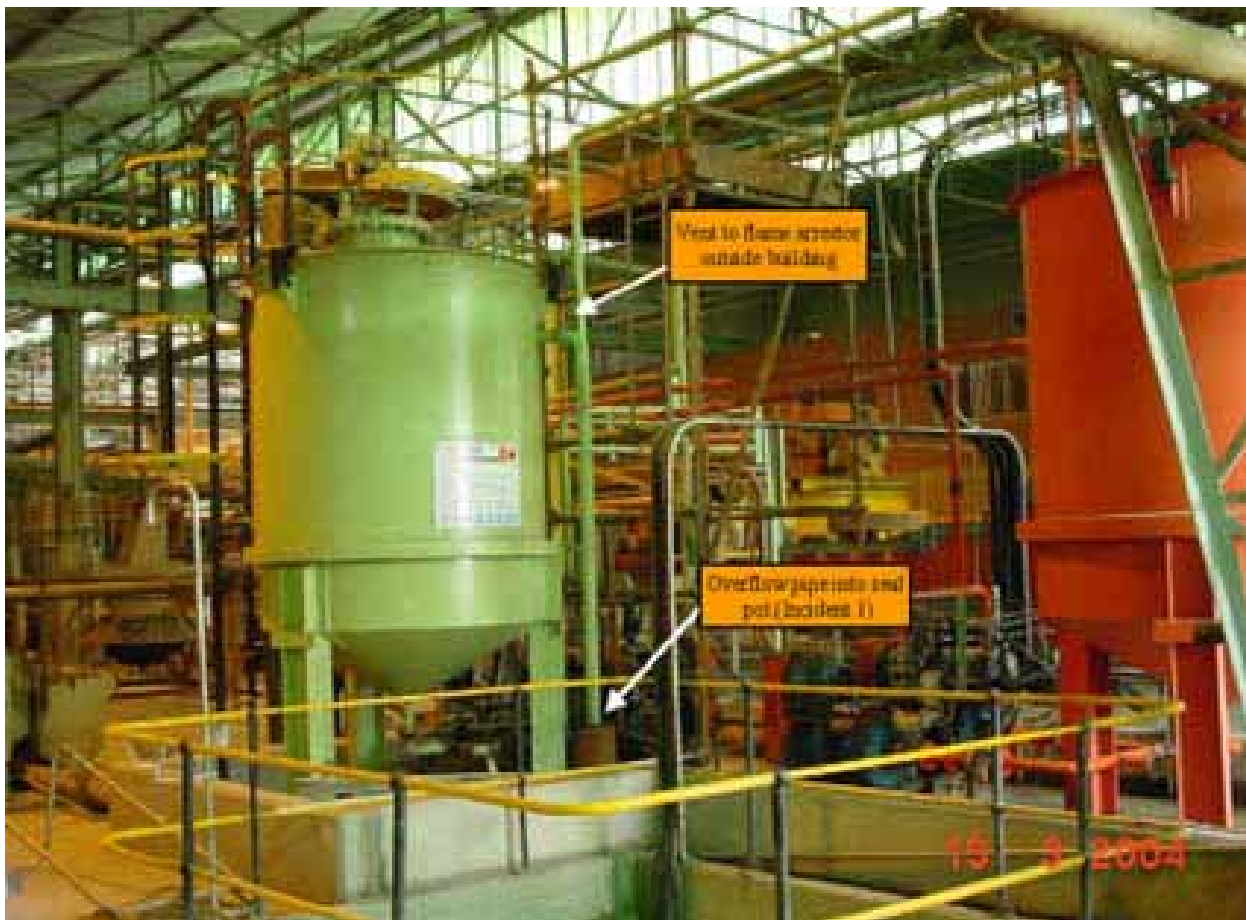
Incident 1 (29 Nov 2003)

This picture shows the MF2 Section xanthate dosing tank (green) and the dithiophosphate dosing tank (orange). These are closed tanks and the initial installation only had open overflow pipes. Diluted liquid xanthate (10%) was being transferred into the xanthate

dosing tank, which in turn was displacing fumes out through the overflow pipe. No safety permit had been requested or issued but a contractor boilermaker was using an angle grinder, approximately 7 metres away from the tanks. The sparks produced reached into the dosing tank bund area and ignited the fumes. The flames were quickly noticed and extinguished and there was no explosion. There were no injuries and no damage to equipment.

- All collector dosing tanks will be closed. Overflows will have seal pots and vent through remote flame arrestors.
- Extraction systems will be installed on all dosing tanks. The extraction systems will be vented through remote flame arrestors.
- Access to both concentrated and diluted reagent storage areas will be restricted.
- Reclassification of the entire collector system will be done.
- Impala personnel will continuously supervise contractors working in collector storage areas. This is in addition to the normal procedures of risk assessment, site induction, and issue of safety permits.

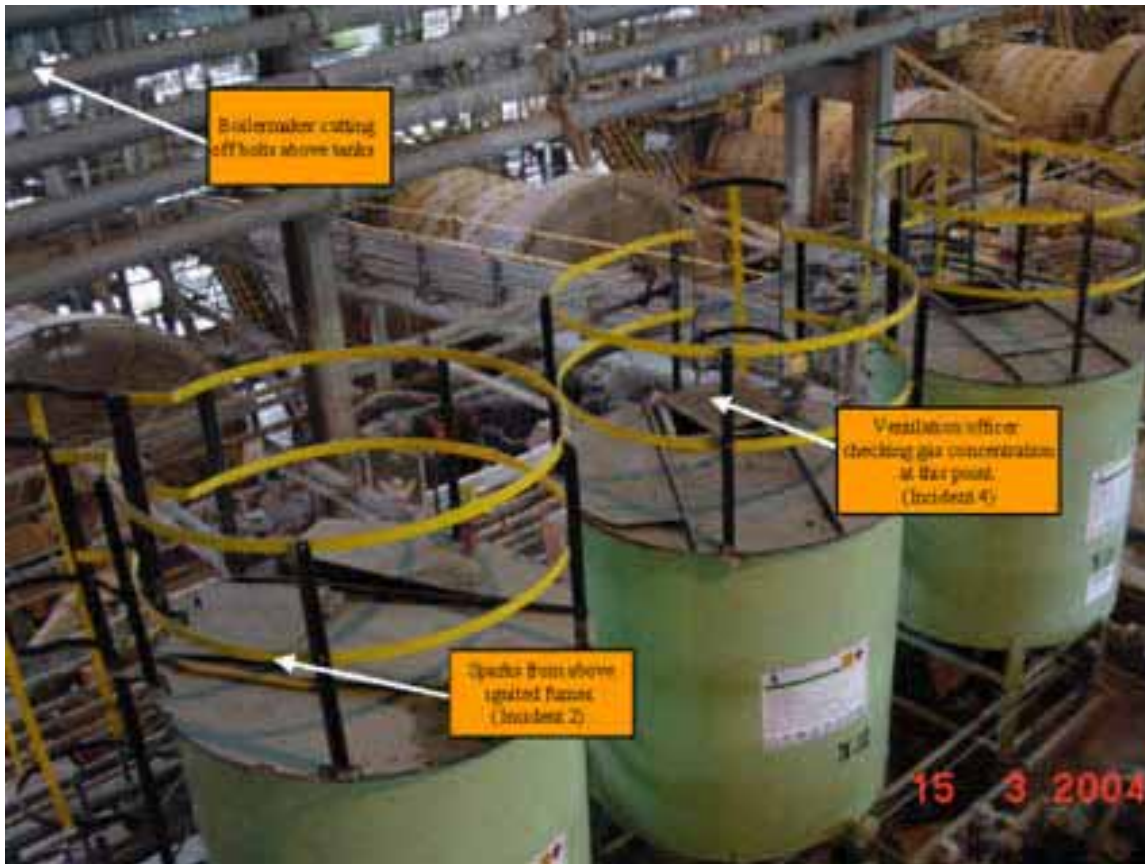
Incidents 2 (3 Feb 2004) and 4 (12 Mar 2004)

This picture shows the Merensky section collector dosing tanks. Whereas initially, the diluted liquid xanthate and dithiophosphate were dosed separately, incidents 2 and 4 occurred after the two collectors were being supplied pre-mixed in concentrated form. The mixed concentrated collector is still diluted on site to a solution containing 10% xanthate and 4.6% dithiophosphate.

In incident 2, no safety permit was requested or issued but a boilermaker was cutting off bolts from pipe flanges about 5 metres above the left hand dosing tank. Sparks were dropping onto and to the side of the tank. These tanks are not sealed and an explosion occurred. There were no injuries and only slight damage to the top of the tank.

In incident 4, a ventilation officer was standing on the middle tank cat ladder testing gas concentration using a Drager pump fitted with a hydrogen tube. This is despite the fact that in the instructions for use, it clearly states that hydrogen tubes should not be used in areas where there is explosion hazard. The manhole cover was open. The tube catalyst heated up sufficiently to ignite the fumes, which continued to burn for about 20 seconds. There was no explosion as such. The ventilation officer suffered a slight burn to his forearm; there was no damage to equipment.

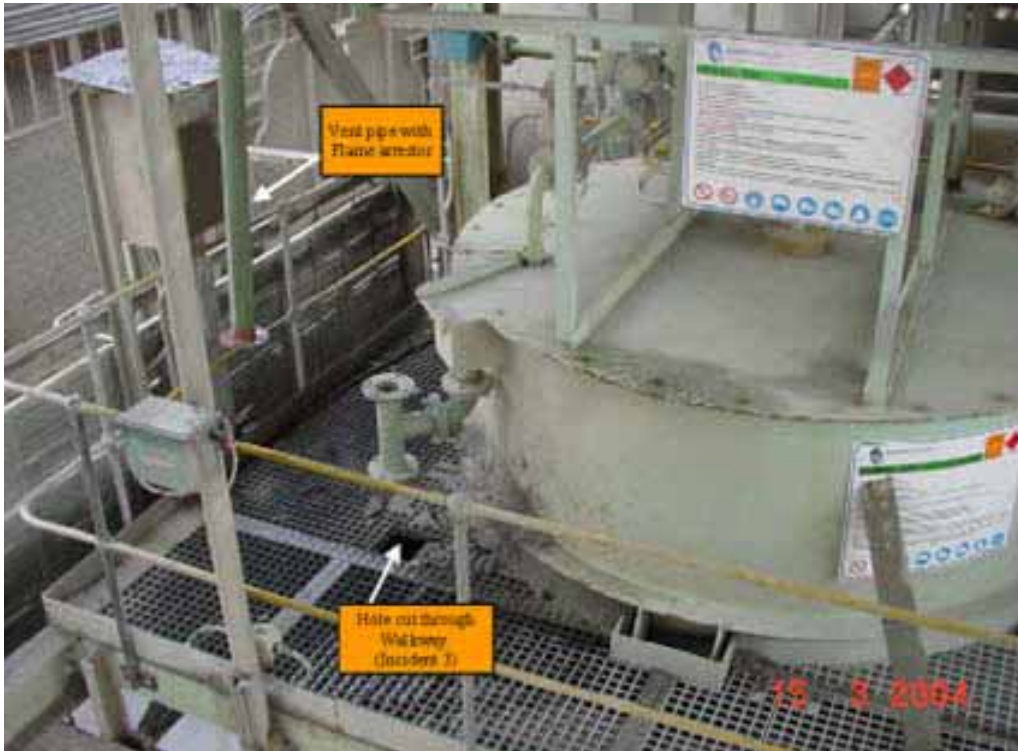
Incident 3 (10 Mar 2004)

This picture shows the tank used to store diluted collector for spike dosing to the Merensky section flotation feed.

Given the other incidents, modifications to reduce the risk of fire and explosion had been planned for this area but not on the day this particular incident occurred. The contractor had been issued a safety permit to work in another area but he took it upon himself to rather work in this area. While cutting a hole through the walkway with an angle grinder fumes from the tank were ignited and an explosion occurred. At the time of the incident, the warning signs had not been positioned as shown. There were no injuries and no equipment damage.
