BEATRIX GOLD MINE

Carbon Breakage Investigation

By: Sello Damoyi

24 October 2008

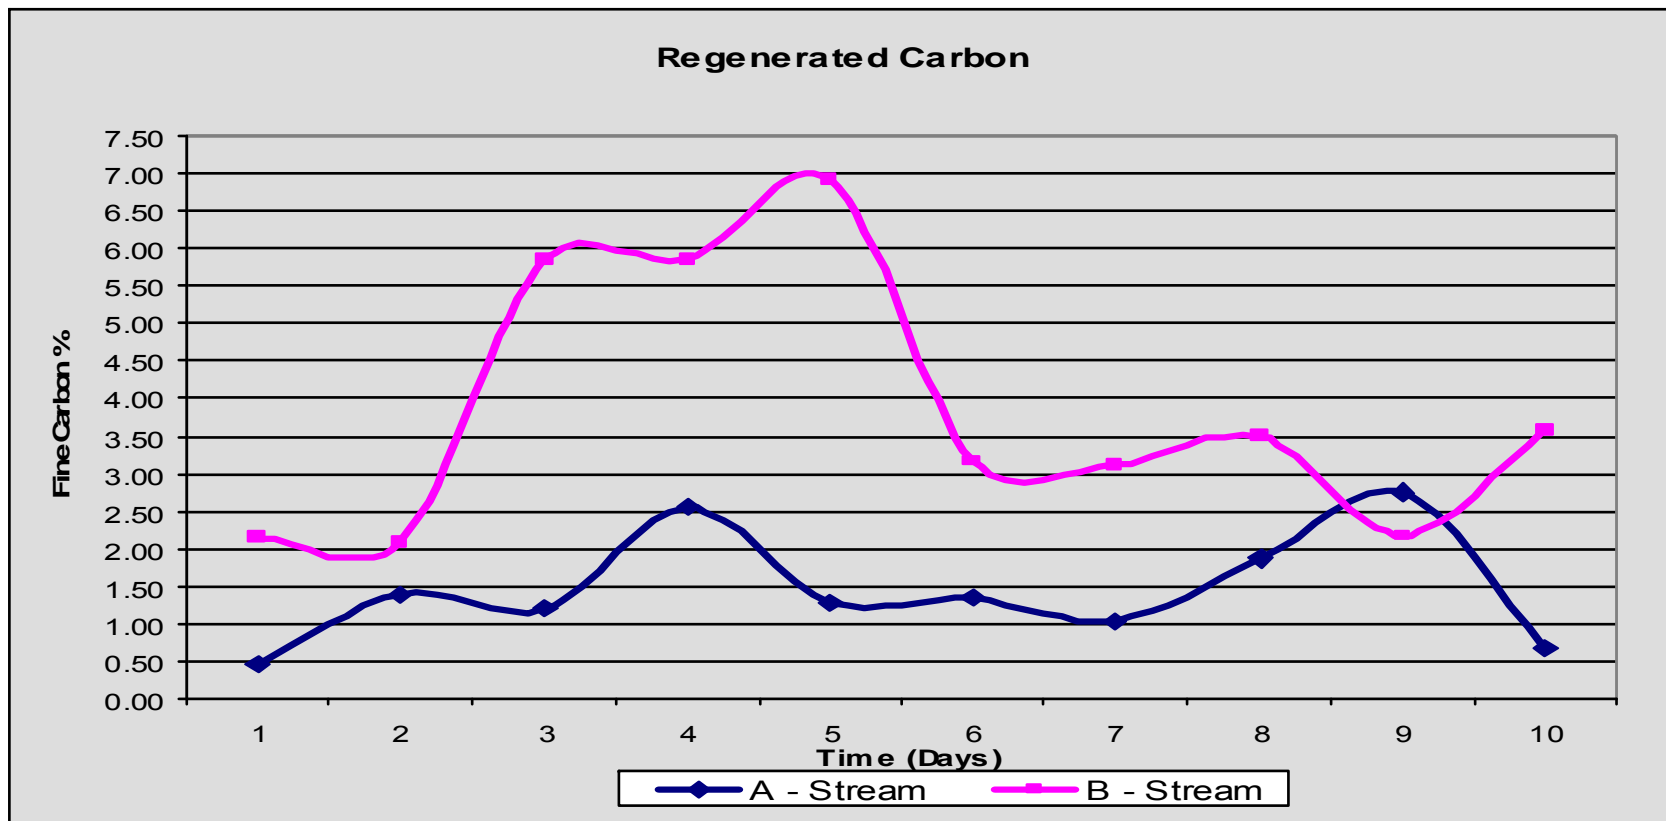
3.2 Elution and Regeneration operations

stream	Eluted (%)	Regeneration (%)	Acid treated (%)
A - Circuit	2.28	8.03	0.81
B - Circuit	3.32	7.17	0.68
